Change of the Inmarsat-C satellite constellation permanently leads to VMS and ERS reporting problems

VMS devices of the type TT-3026 need an update!

Ausgabe	Version	Dokumentenname/Zeichnungsnummer	Seite
03.01.2019	0	VMS+ERS Reporting Gaps after I4 Shift.docx	1 von 2

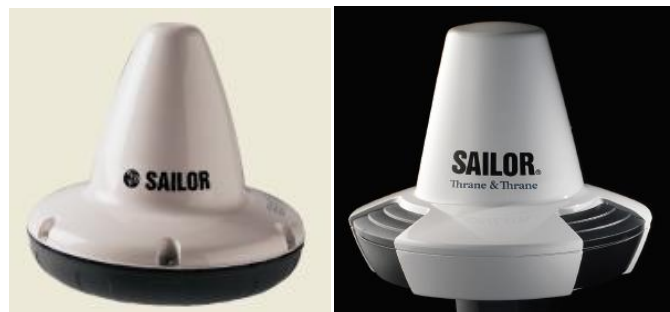
All types of TT-3026 used on German fishing vessels are affected, provided that they were last programmed/tested before December 18th 2018. Not affected are all TT-3027 devices. The antennas are easy to distinguish optically.

TT-3026 (affected)

TT-3027 (not affected)

The devices are characterized by their particular robustness. The failure statistics now show a mean life expectancy of more than 25 years. The problems caused by the satellite shift can be solved by device replacement, i.e. by replacing it with a new type TT-3027M with TCU. The antenna cable and the below deck unit (InfoBox) must also be replaced. An exchange should be considered if the device is already very old or shows other weaknesses.

The problem can also be eliminated by reprogramming to a modified satellite selection logic. If necessary, the firmware has to be exchanged if it is older than version 2.26. Programming, firmware renewal and testing can usually be carried out remotely with www.iks-hh.de/support/iks-fernwartung.exe without dismounting the system.

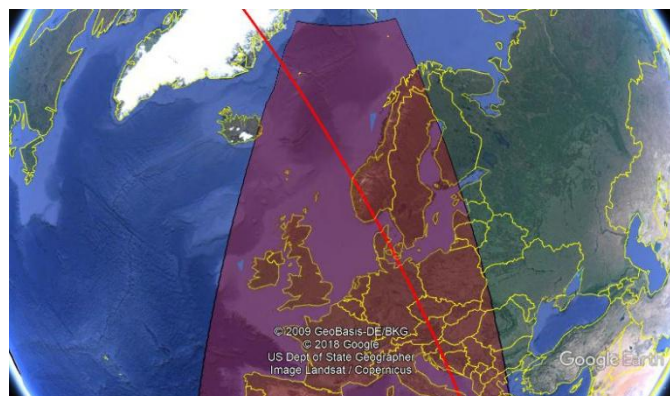
Affected Area

The problem exists in all positions closer to the IOR than to the AORE satellite, i.e. in the range of longitudes between 14° W and 24° E.

The biggest problems are to be expected at a low AORE elevation angle, i.e. several 100 nautical miles on both sides of the red marked 5° elevation limit of the AORE.
